Manhole Inspection Summary

Manhole # S07AA2004MH

Insp Date: **9/18/06 3:28 PM**

Location Address: **5841 WESTERN RUN DR**

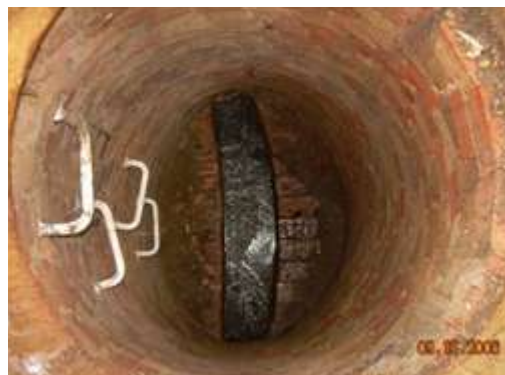
Top View

Frame offset. Adjustment and Corbel infiltration. Bench debris. Channel debris.

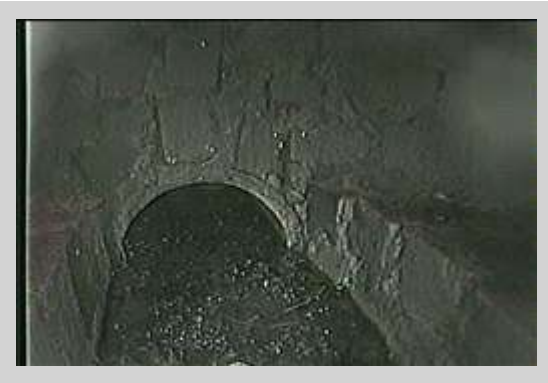
8 in. Circular Gravity Sewer Pipe Out @ 12 O'Clock

Barrel deterioration and infiltration.

Infiltration: **Evidence** Pipe Seal Cond: **Cracked**

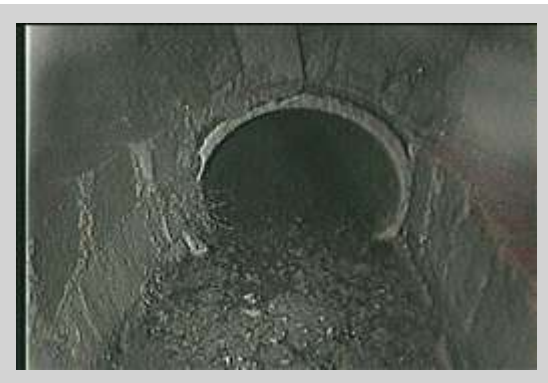
8 in. Circular Gravity Sewer Pipe In @ 6 O'Clock

Channel deterioration and root intrusion.

Infiltration: **Evidence** Pipe Seal Cond: **Roots**
